Figure 4-1. Decision diagram for landfill waste characterization with contingent monitoring, capping, or excavation.

Figure 4-7. Locations of Site 300 soil and/or landfill waste remediation modules.

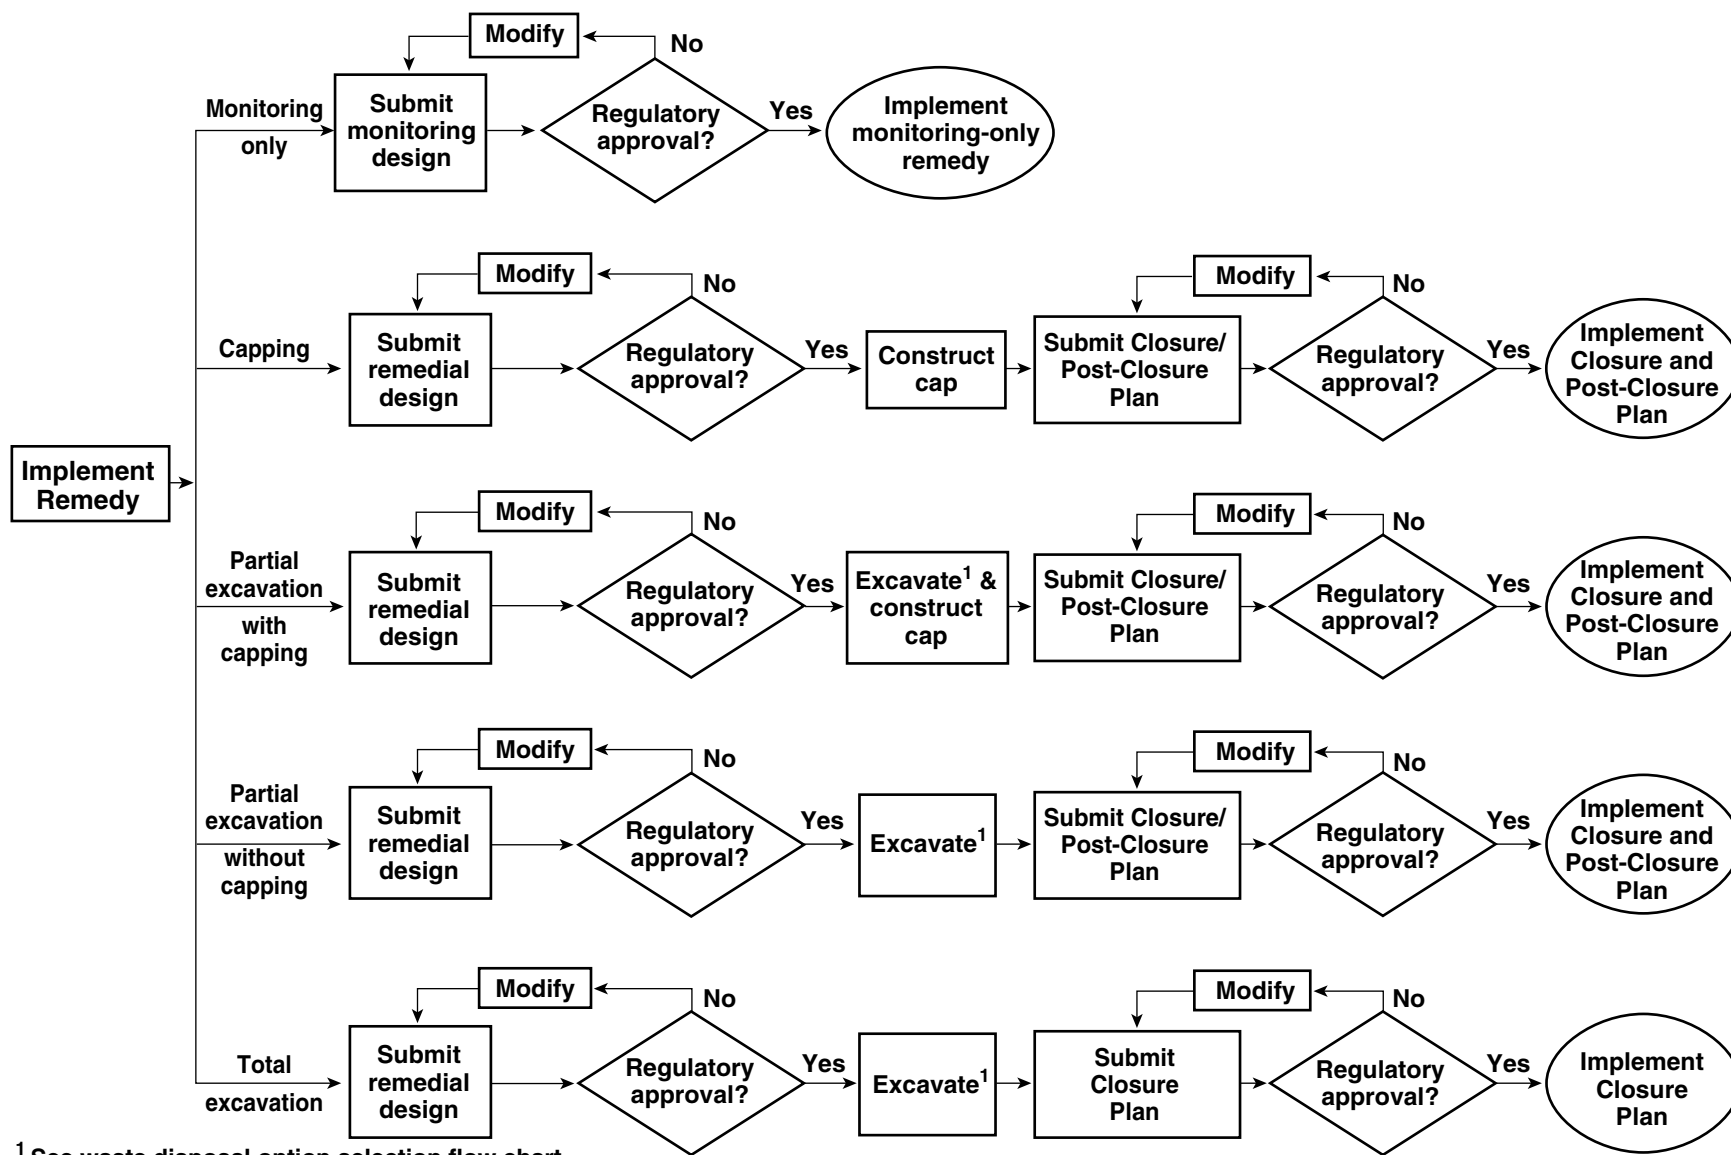
ERD-S3R-99-0079

Figure 4-1. Decision diagram for landfill waste characterization with contingent monitoring, capping, or excavation (Page 2 of 3).

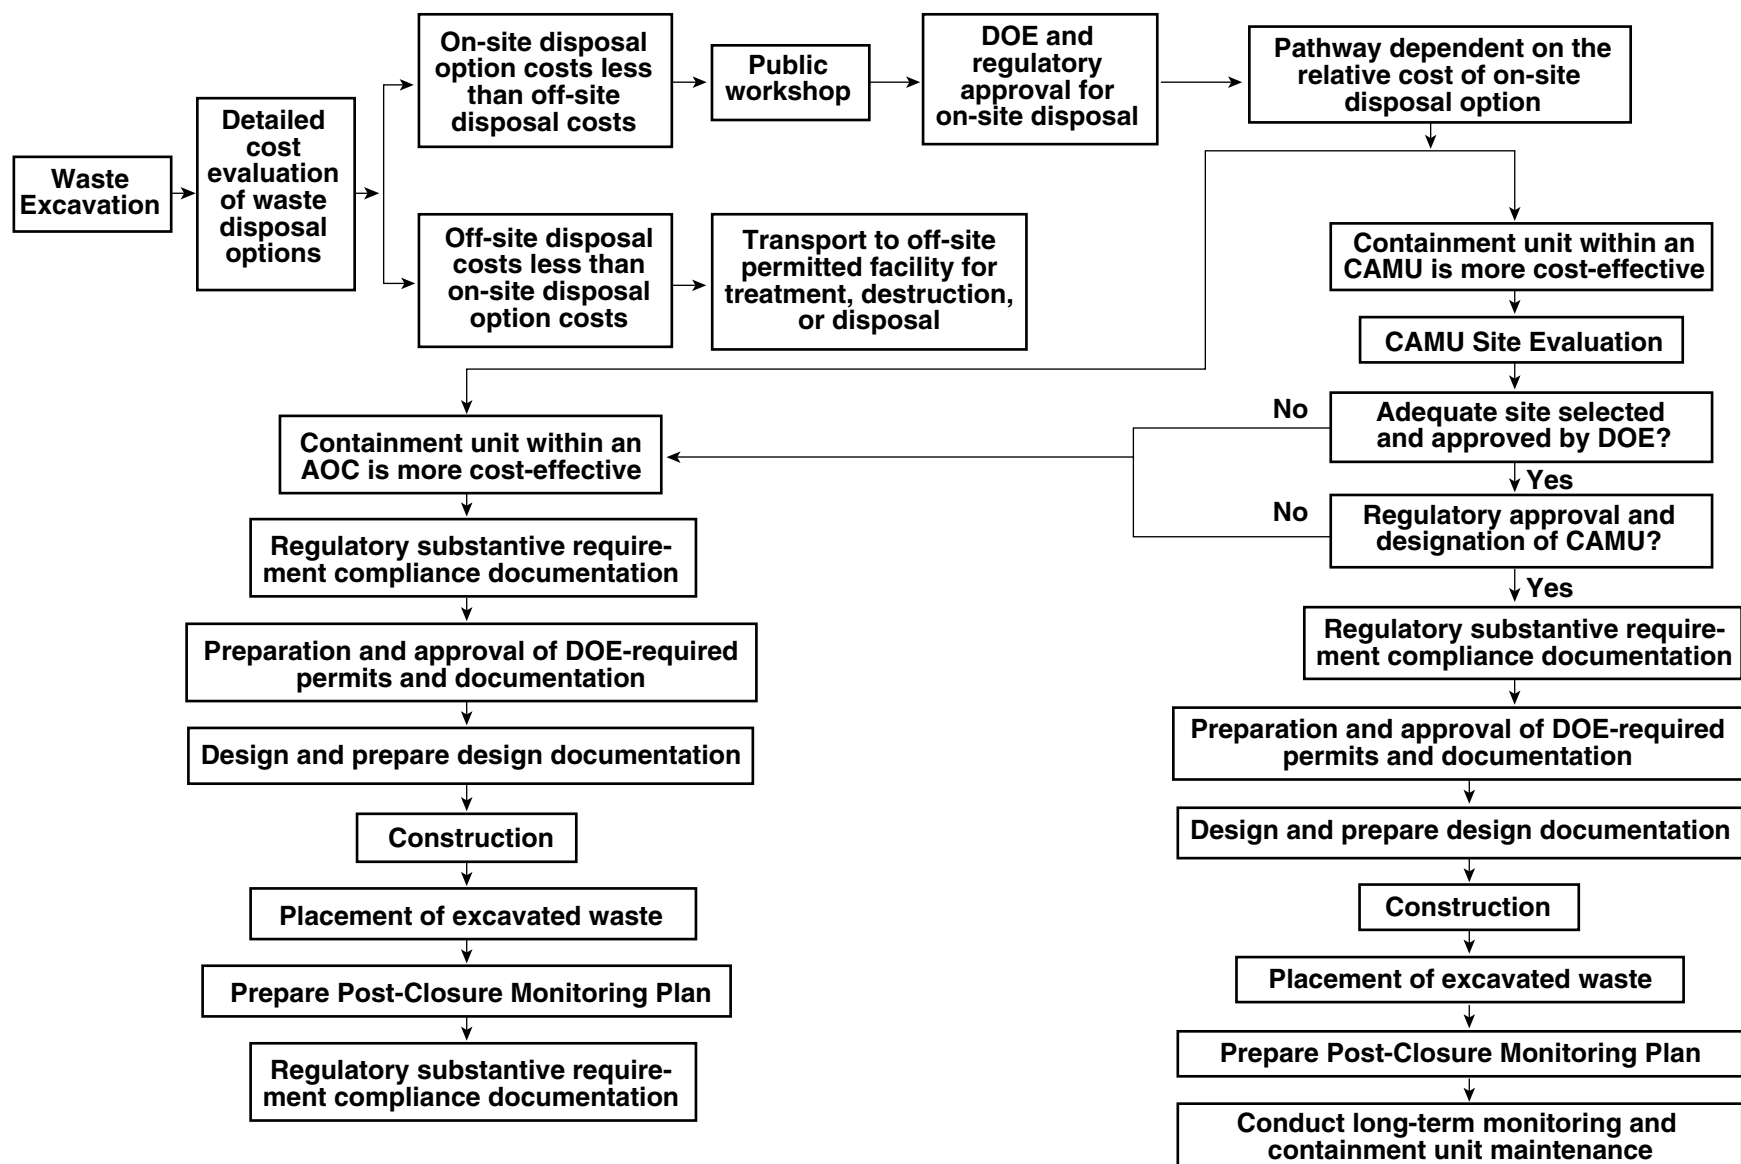
ERD-S3R-99-0148

Figure 4-1. Decision diagram for landfill waste characterization with contingent monitoring, capping, or excavation (Page 3 of 3) (waste disposal option selection flow chart).

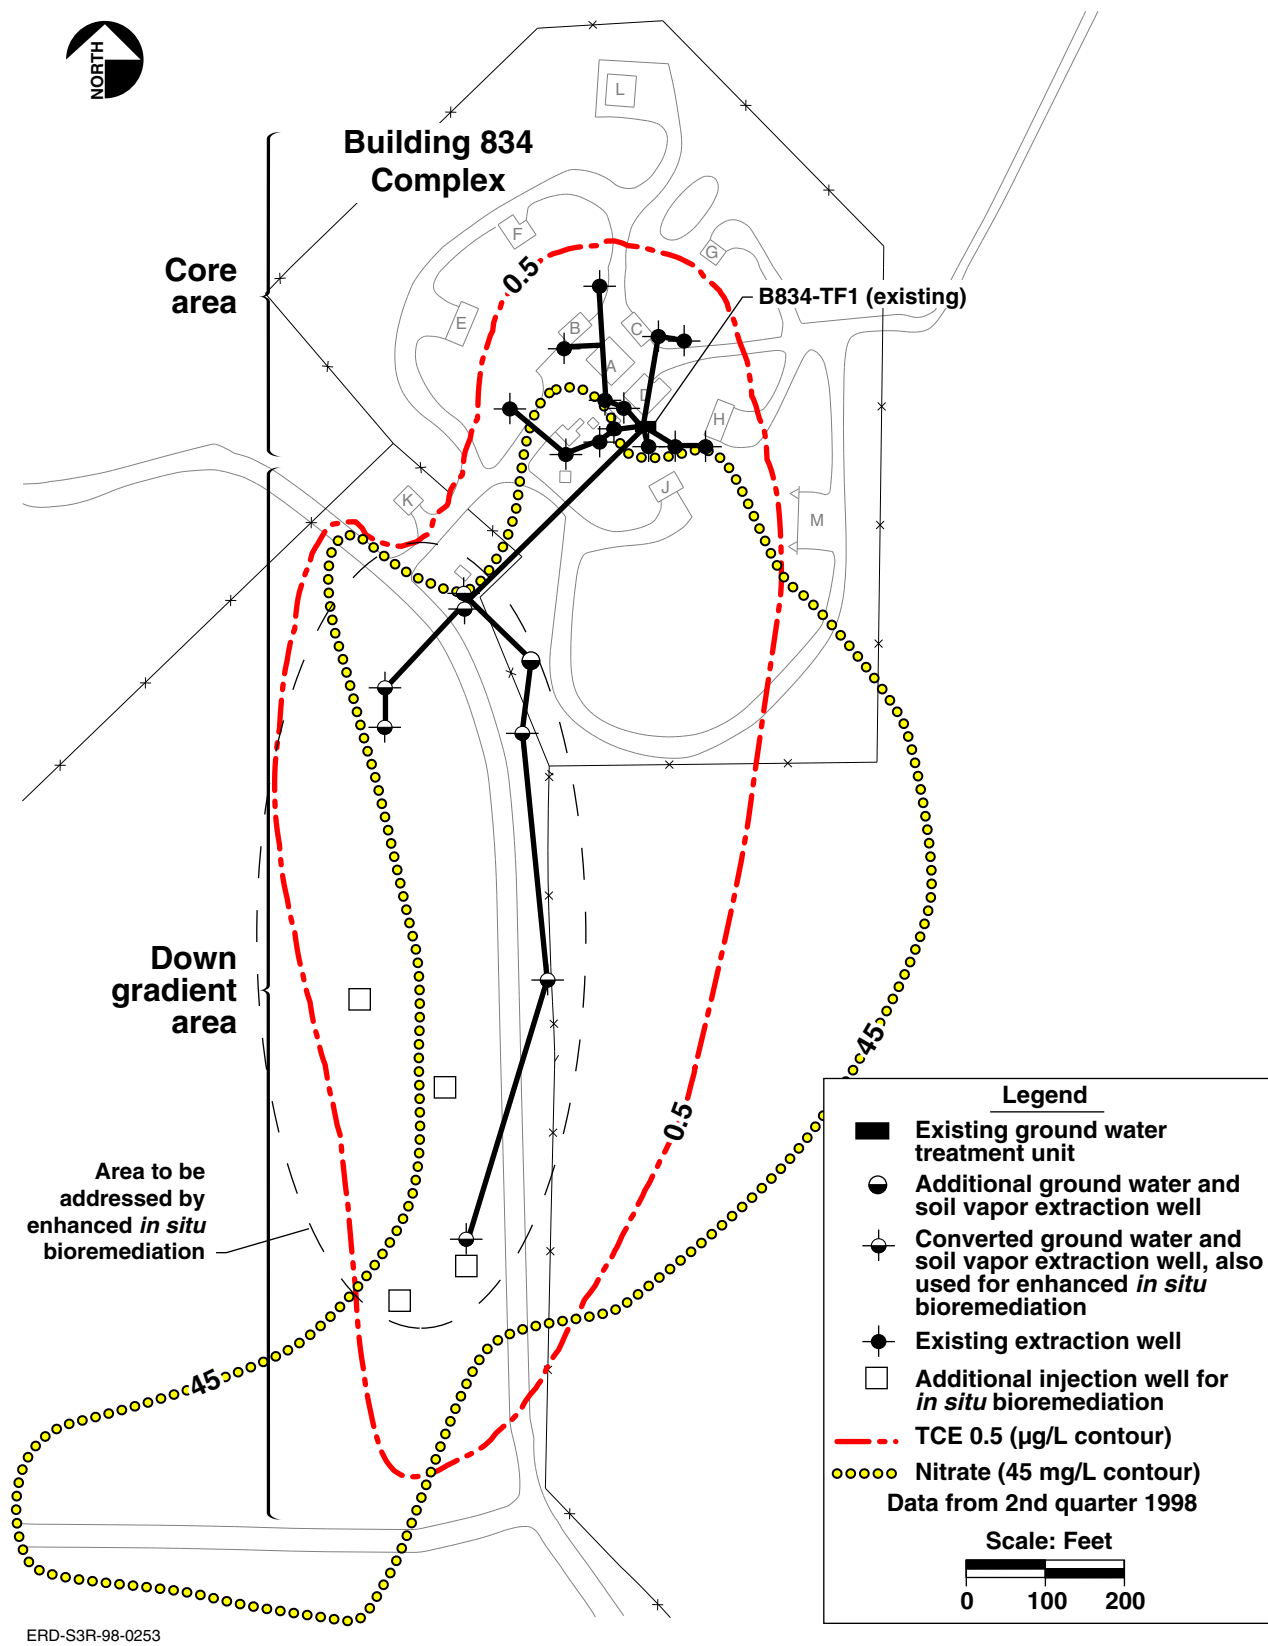
Figure 4-2. Locations of components of the Building 834 remediation modules, (OU2).

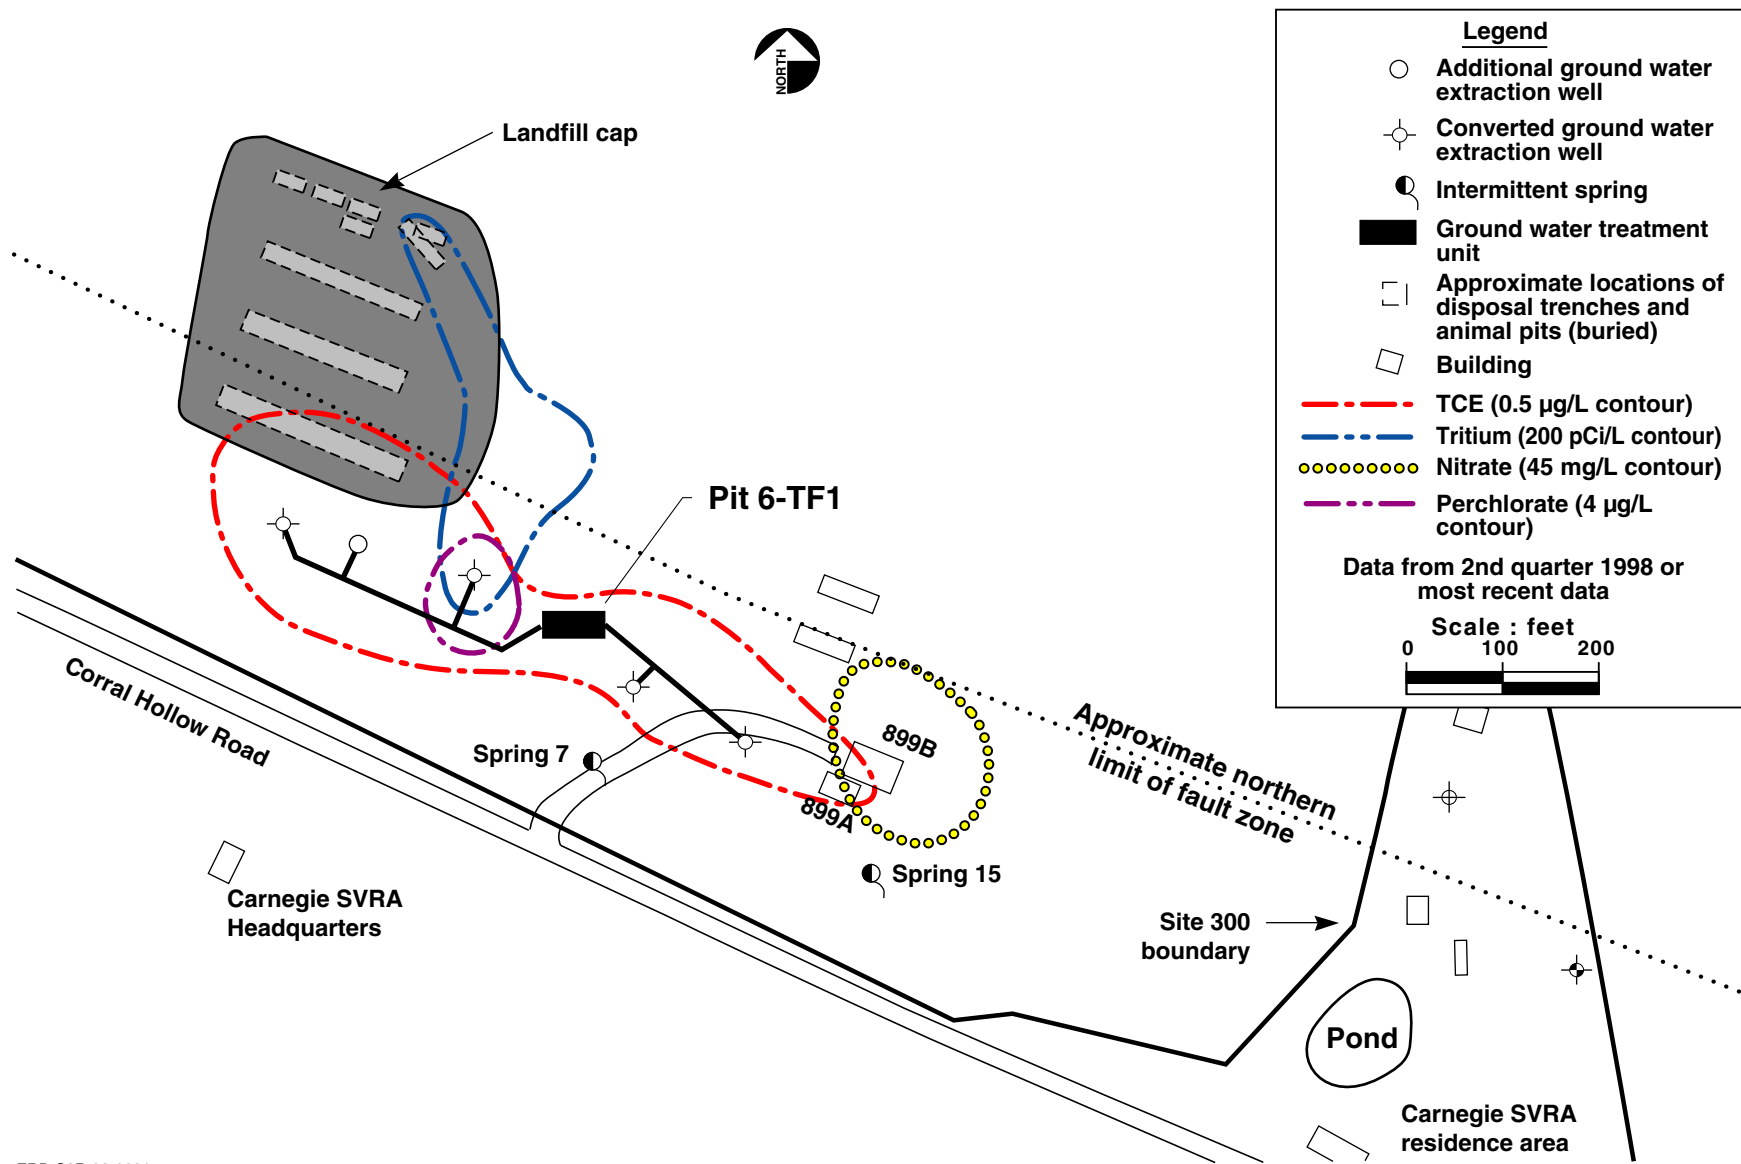
ERD-S3R-98-0201

Figure 4-3. Locations of components of the Pit 6 remediation modules, (OU3).

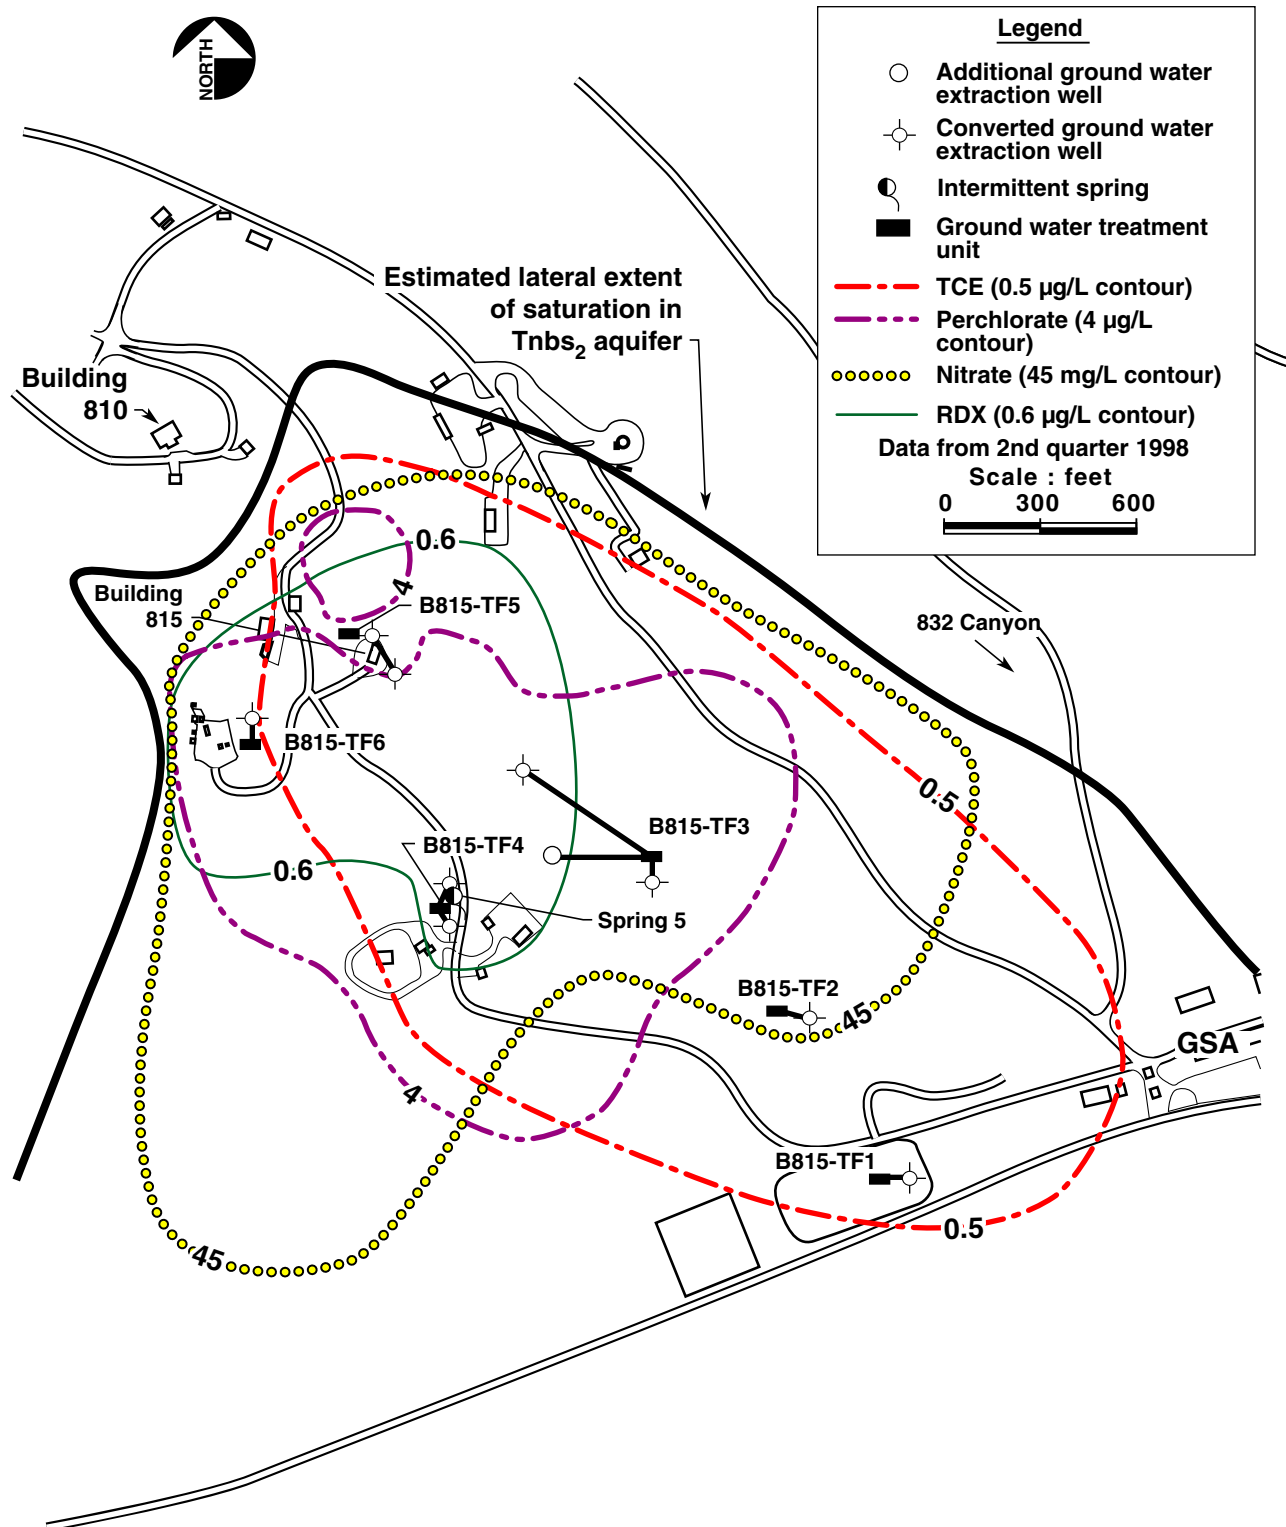
ERD-S3R-98-0280

Figure 4-4. Locations of components of the HE Process Area remediation modules, (OU4).

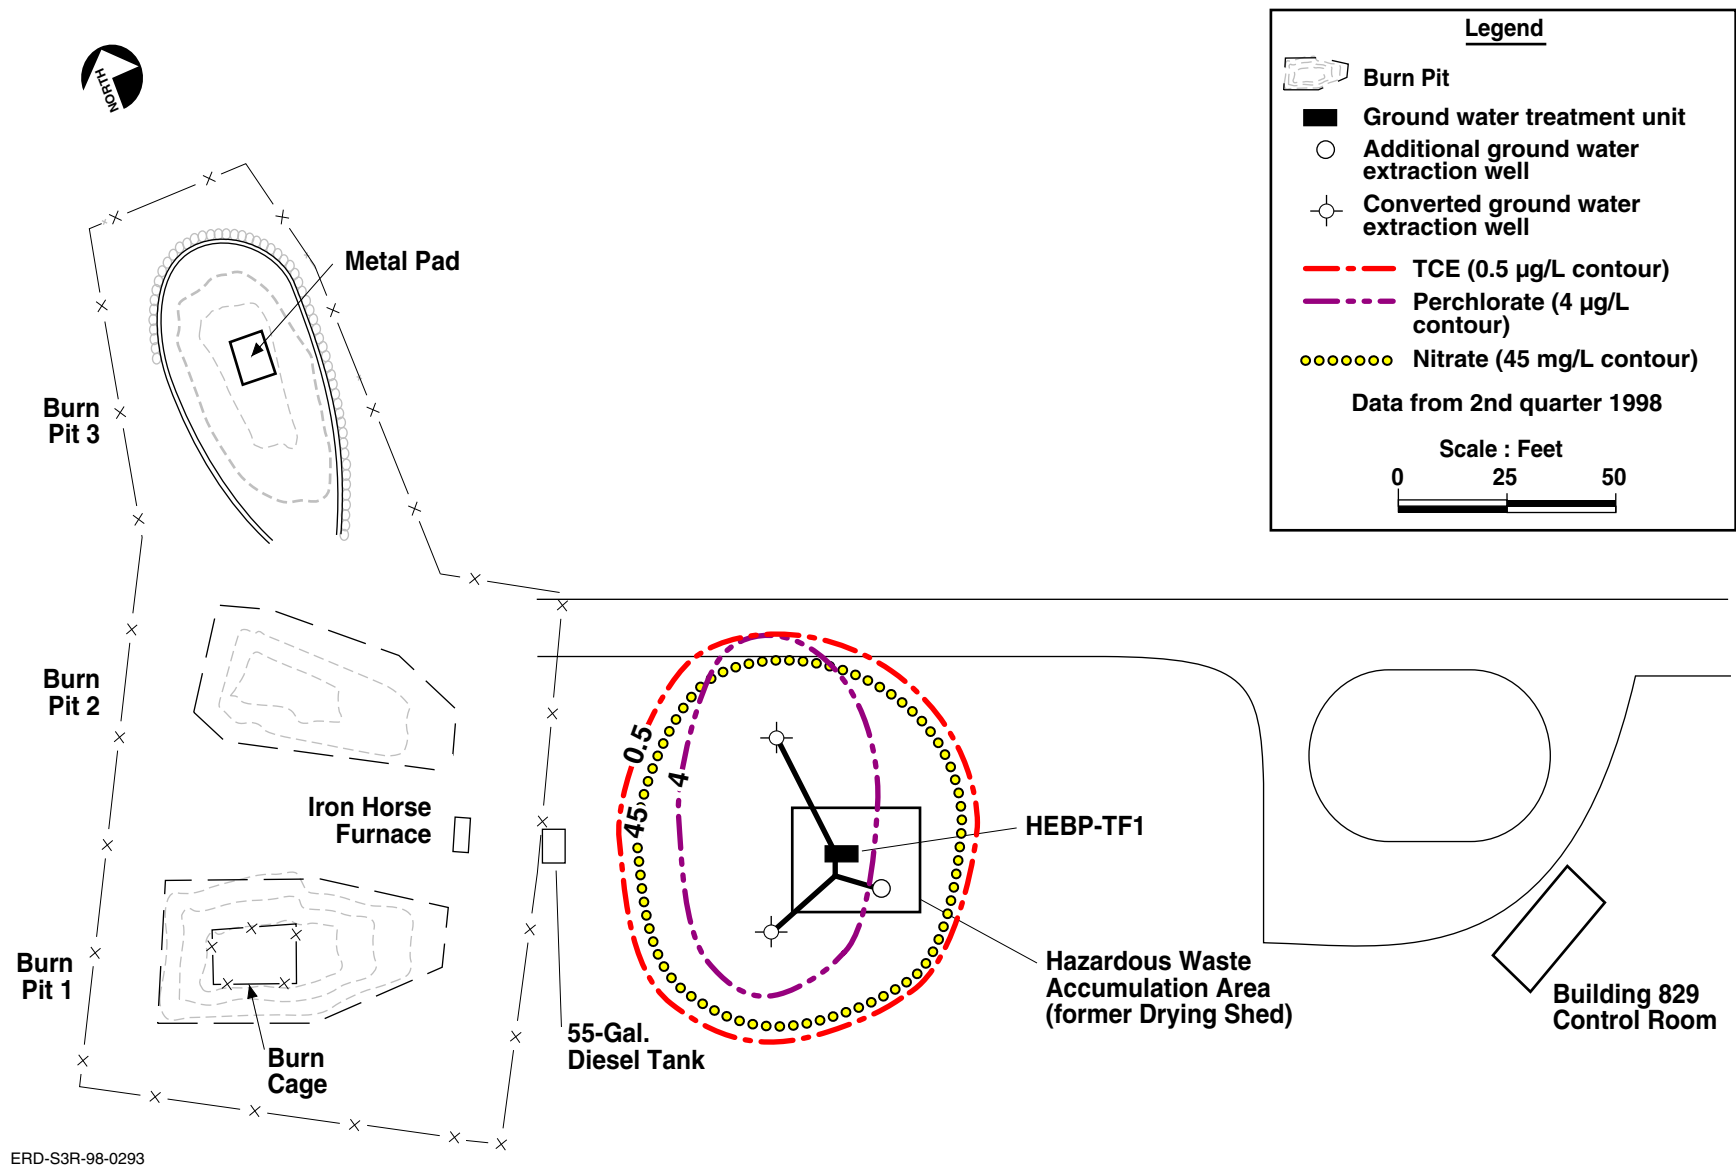
Figure 4-5. Locations of components of the HE Burn Pit portion of the HE Process Area remediation modules, (OU4).

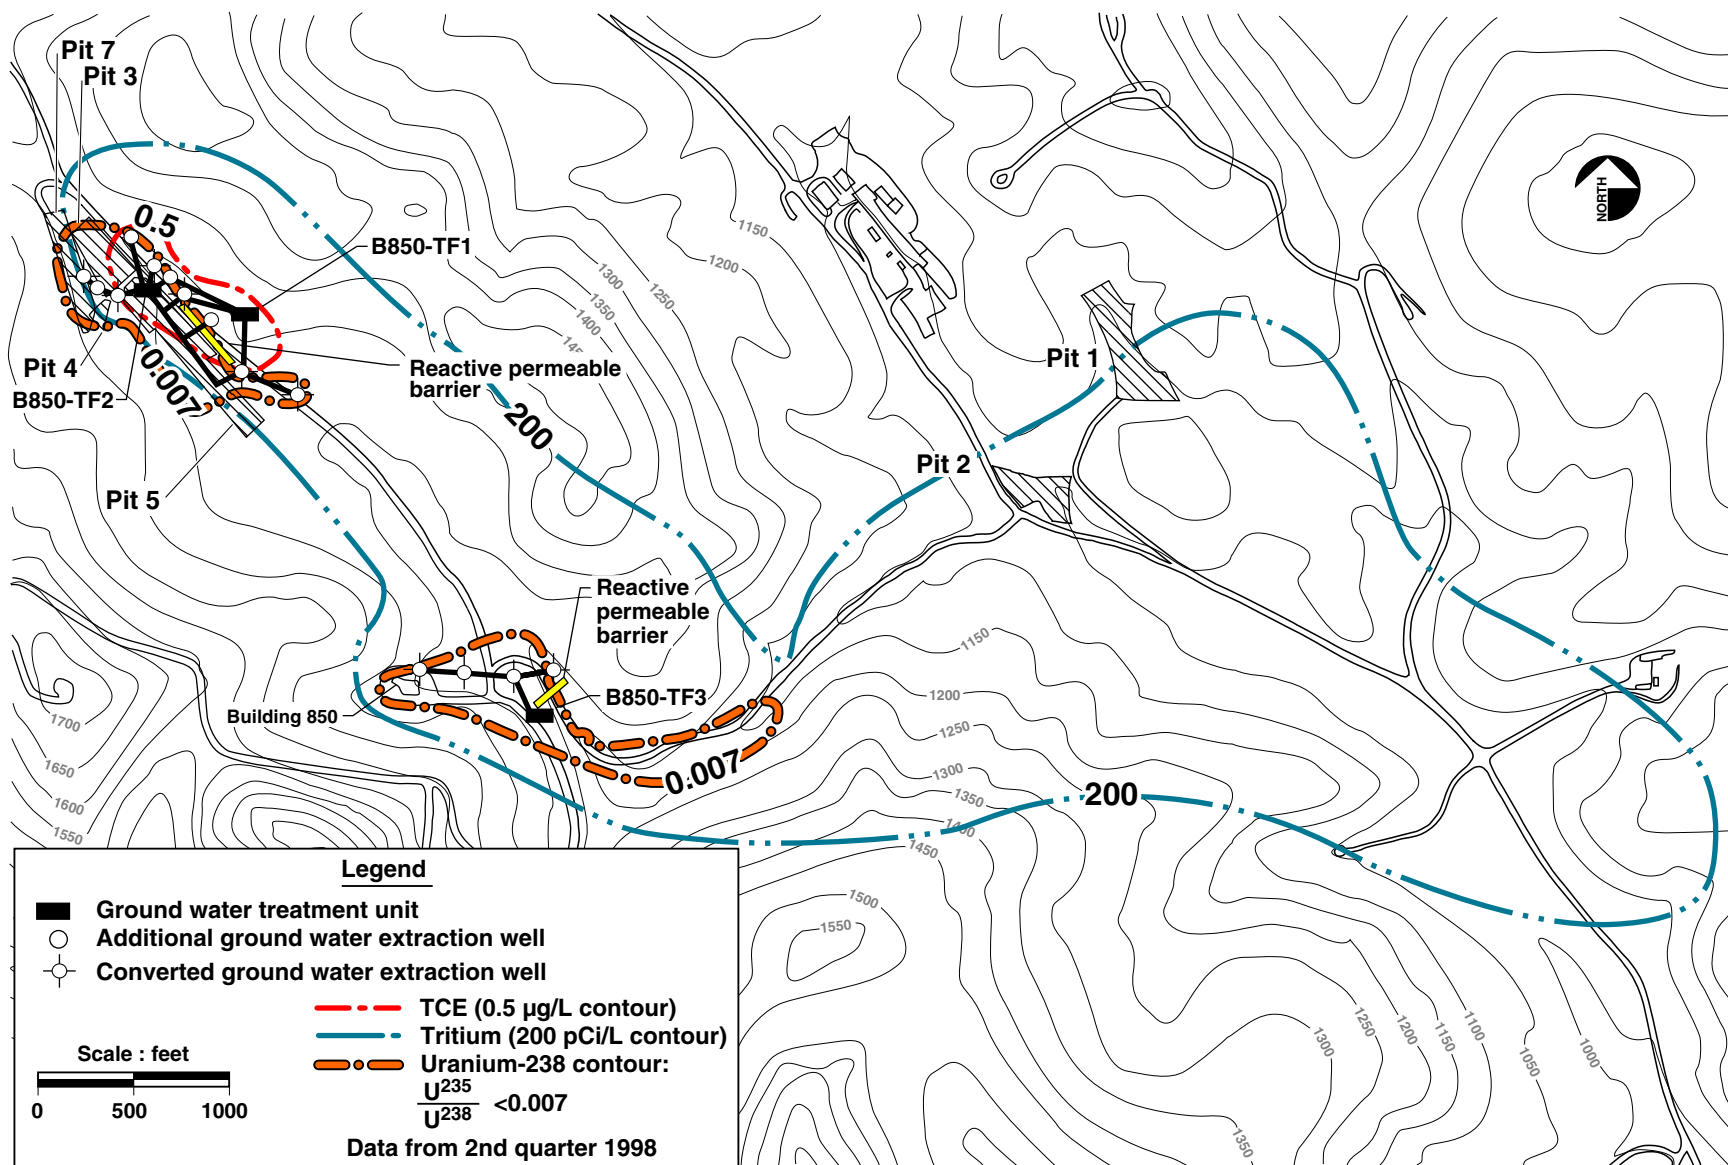
ERD-S3R-98-0254

Figure 4-6. Locations of components of the Building 850 and Landfill Pit 7 Complex remediation modules, (OU5).

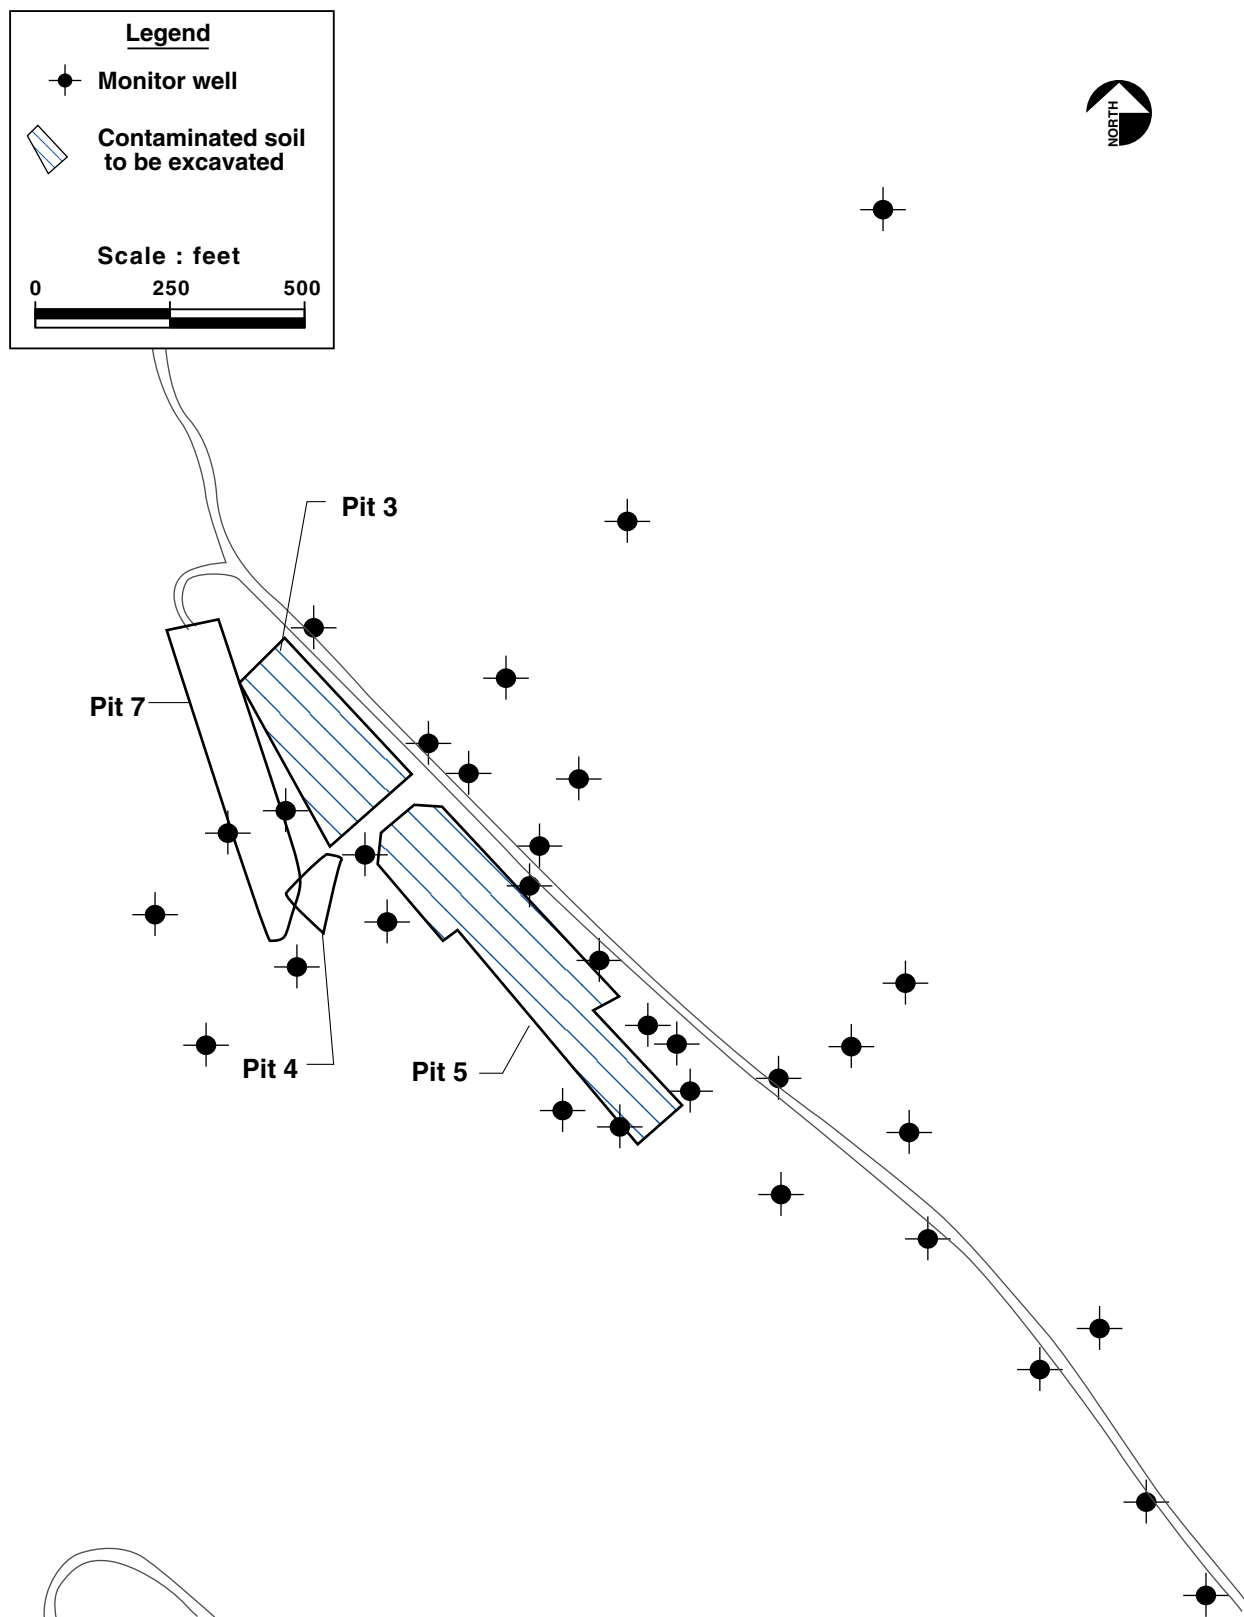
ERD-S3R-98-0286

Figure 4-8. Locations of contaminated soil to be excavated for the Landfill Pits 3 & 5 remediation modules, (OU5).

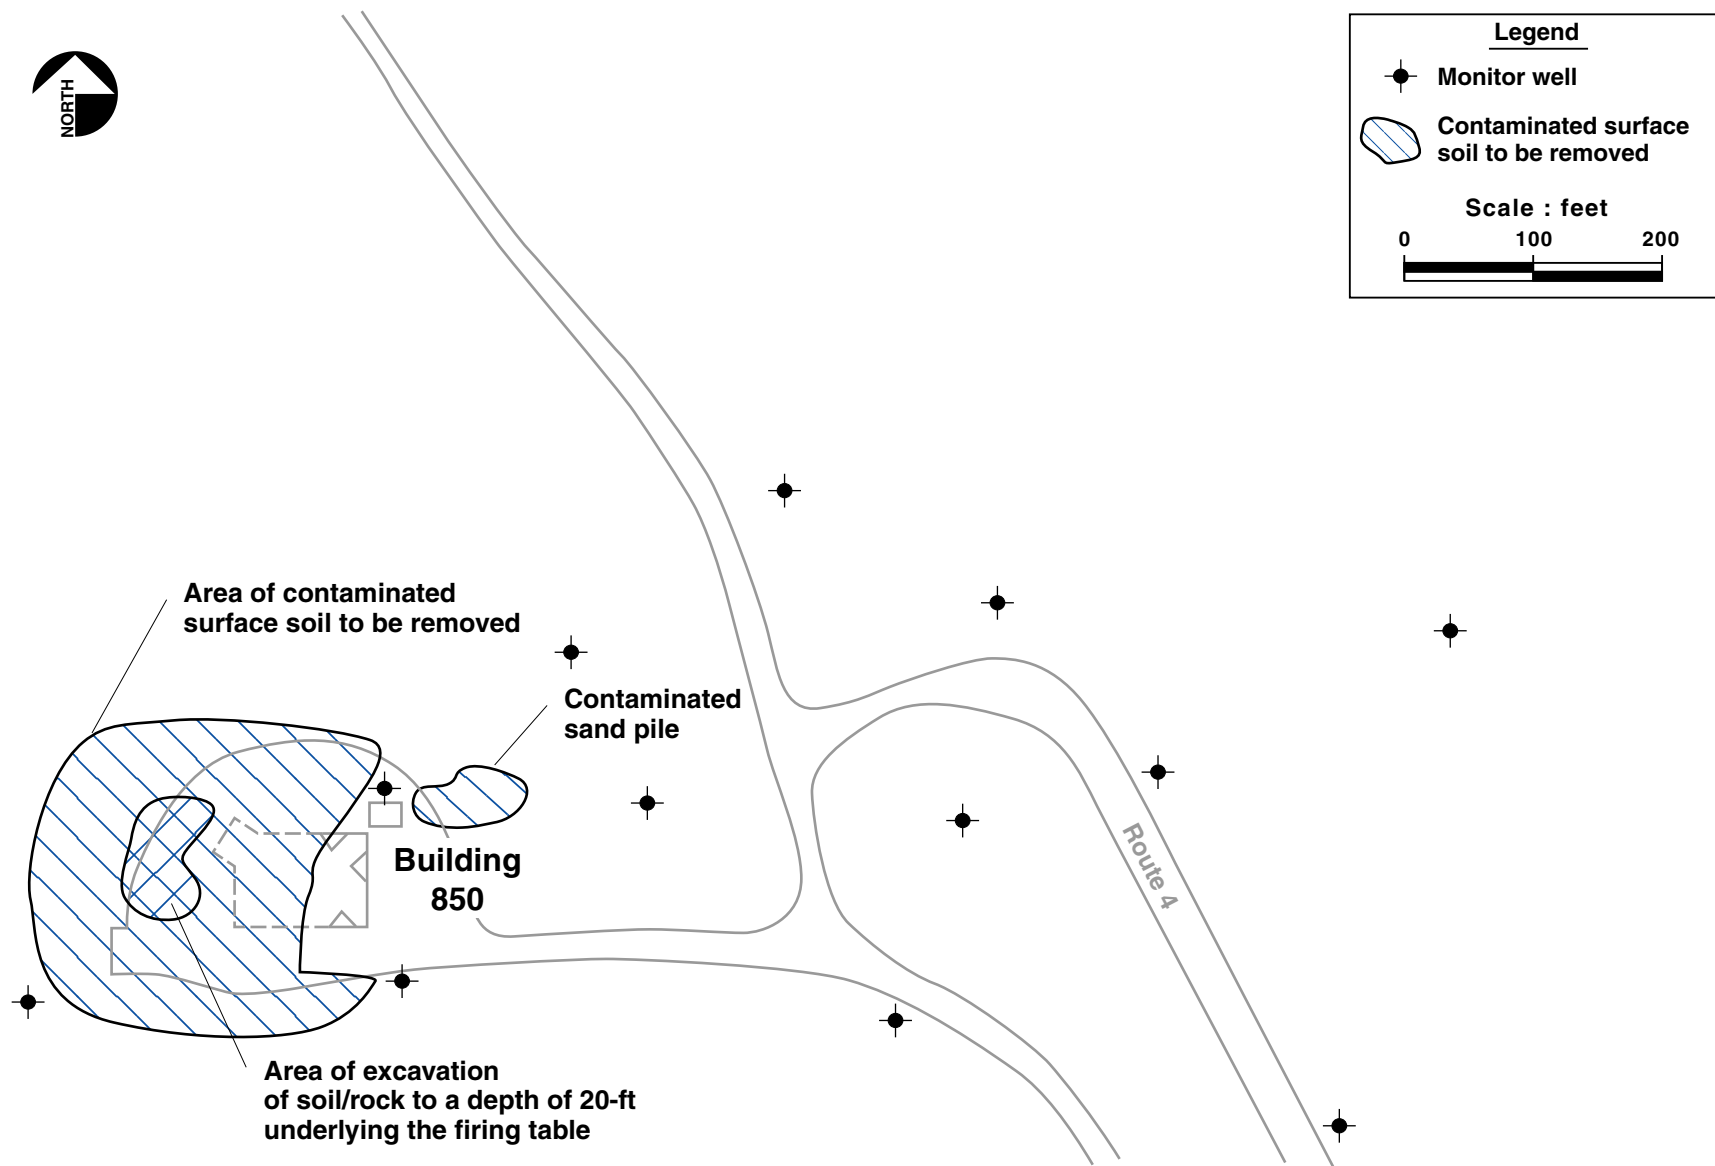
Figure 4-9. Location of contaminated soil to be removed for the Building 850 firing table remediation modules, (OU5).

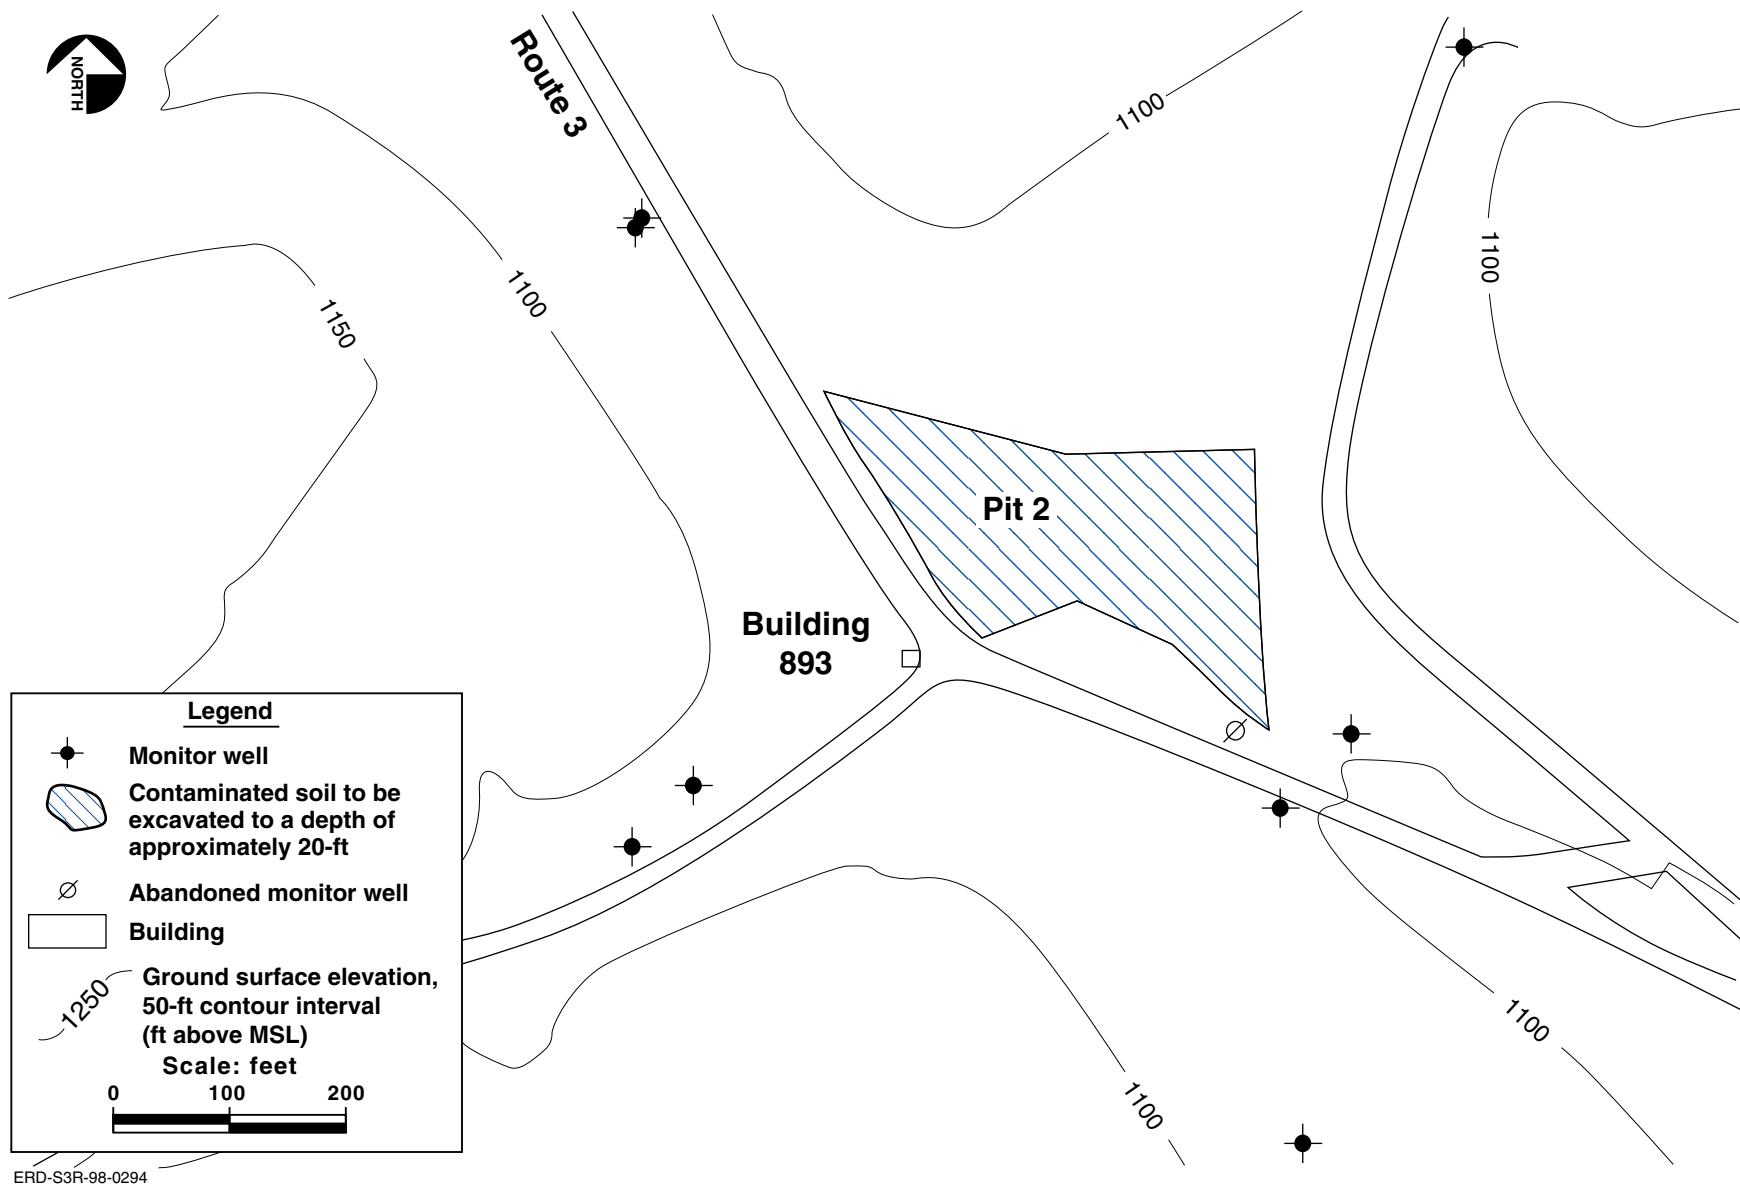
Figure 4-10. Locations of contaminated soil to be excavated for the Landfill Pit 2 area remediation module, (OU5).

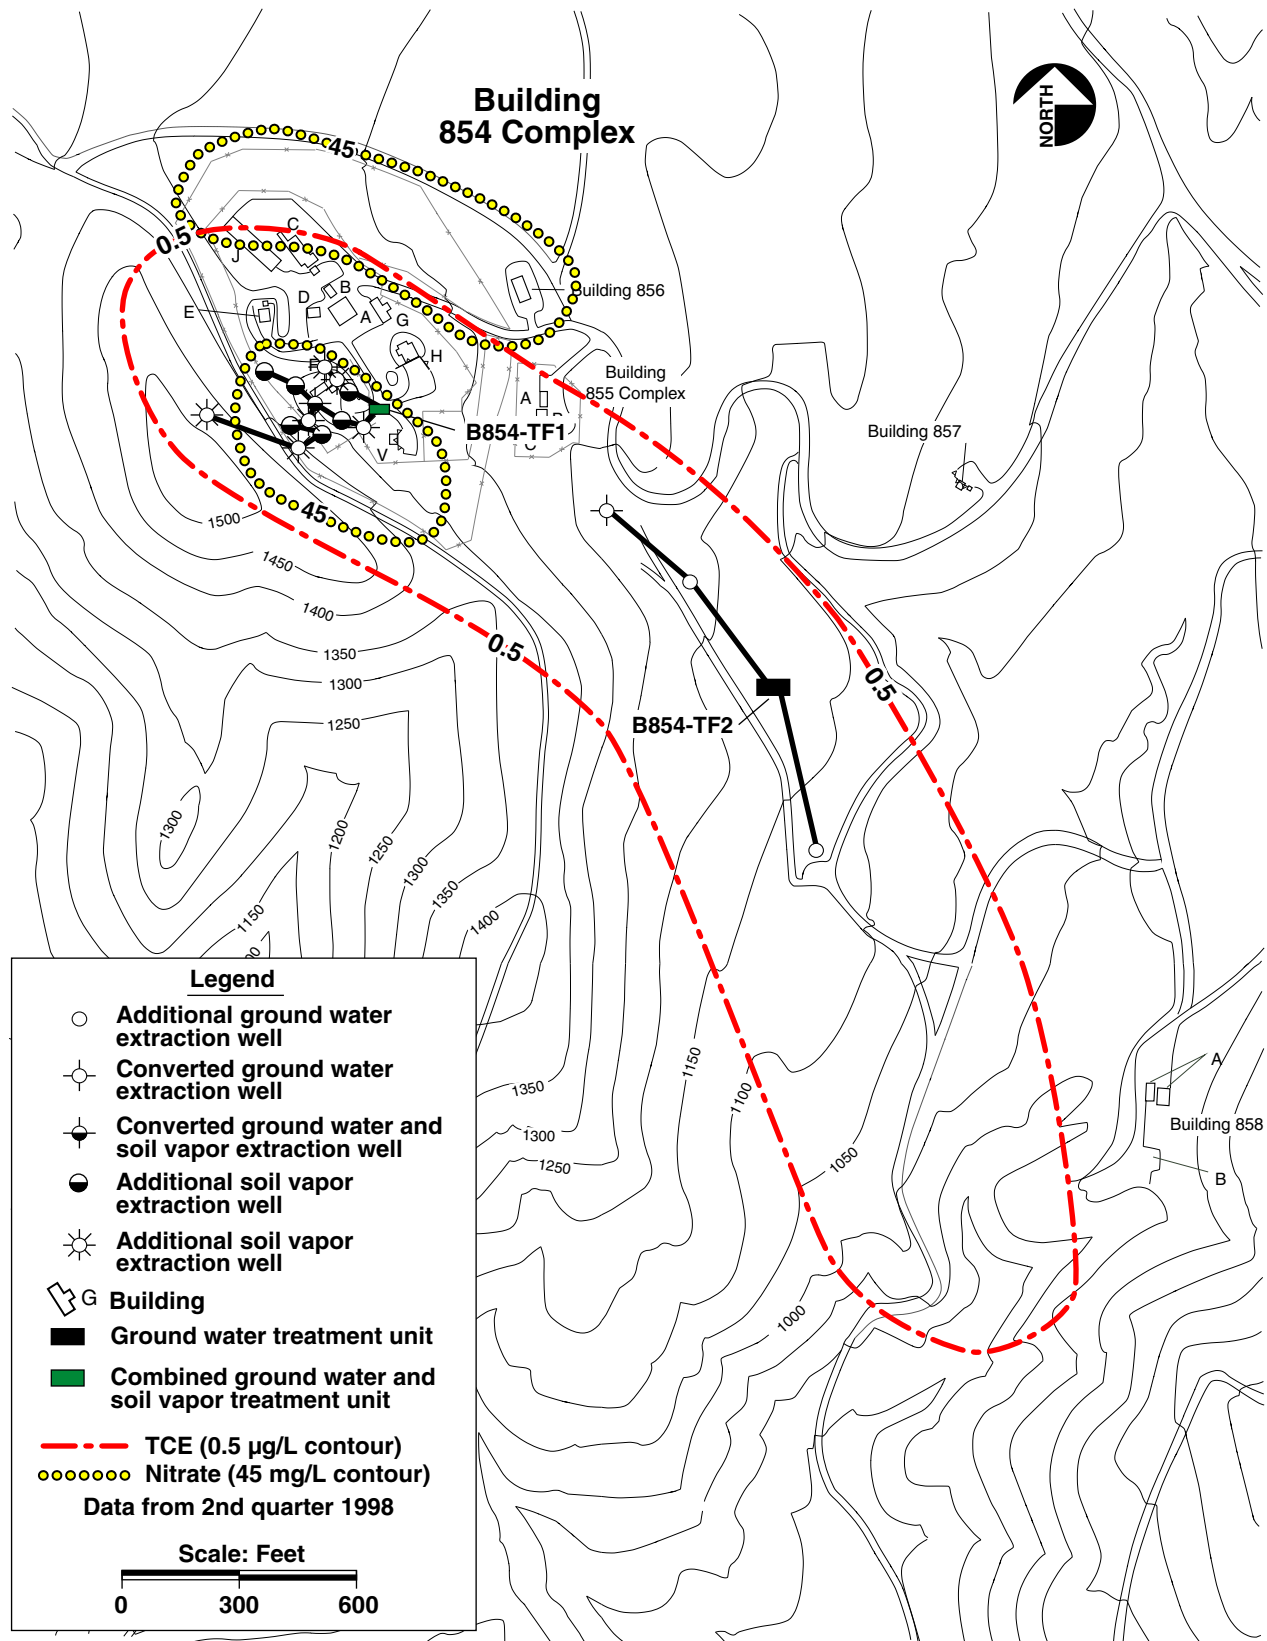
ERD-S3R-98-0257

Figure 4-11. Locations of components of the Building 854 remediation modules, (OU6).
